Allied HVAC Distributors

Technical Service Tip (AST 001-15)

RUUD HEAT PUMP – Possible Defrost Sensor Issue

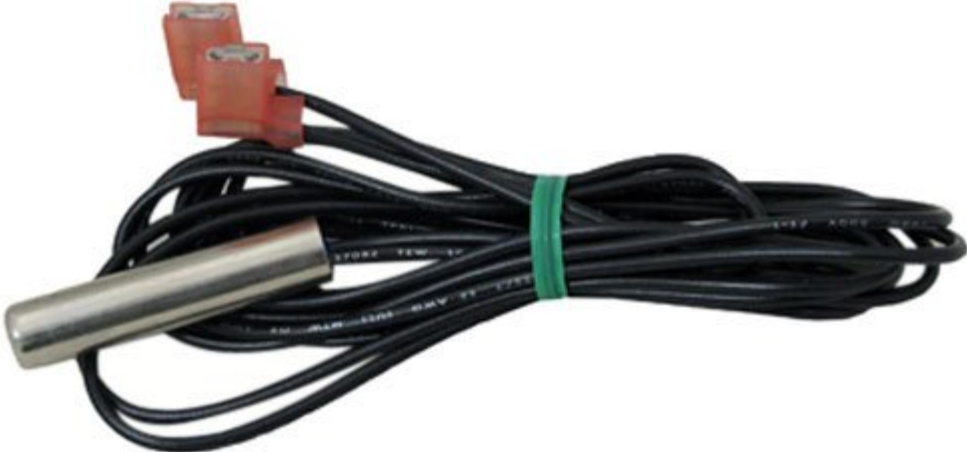
It has recently been brought to Allied HVAC's attention that there has been an increased number of defrost related problems across most of the RUUD Heat Pump model's , the problem manifests itself as a unit that will not go into defrost. The problem we believe is contributed to a faulty defrost coil sensor that when exposed to moisture will read out of range and not allow defrost to initiate. When dry the sensor may read correctly and test properly. At this time we have not been notified of a date range of units that these sensors were supplied in.

The affected sensors are SILVER in color and were only used on the manufacturer's production line, they have not been used or supplied in replacement parts. (Both SILVER and BRASS colored sensors were used on the manufacturer's production line)

Affected Sensor Color (Silver Colored)

If you are servicing a RUUD Heat Pump that appears to not be defrosting and has the SILVER colored sensor you may wish to check the operation of the sensor before condemning the entire defrost board. Attached is the ohms readings chart for your convenience and it may also be found under the Tech Support tab at www.alliedheatingac.com

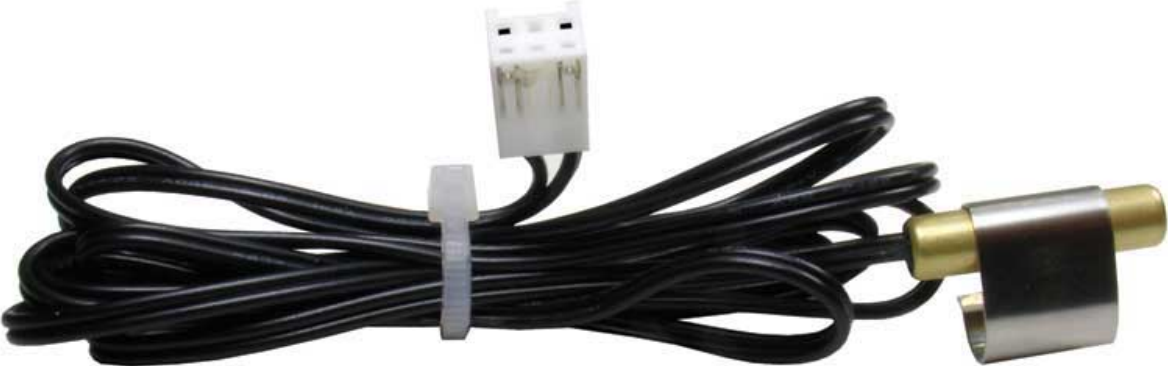
The replacement sensors that are available as single parts or come with a replacement defrost board and are BRASS in color and are not affected by the moisture problem.

Replacement and unaffected sensor (Brass colored)

The replacement part # for sensor only is 47-102710-02
