**RE: ALSN-0208-21 Defrost Control Sensor Failures**

**Description:** All Residential Split Heat Pumps and Commercial Packaged/Split Heat Pumps

**Impacted Date Range:** Units manufactured with date codes W2719 thru W0321

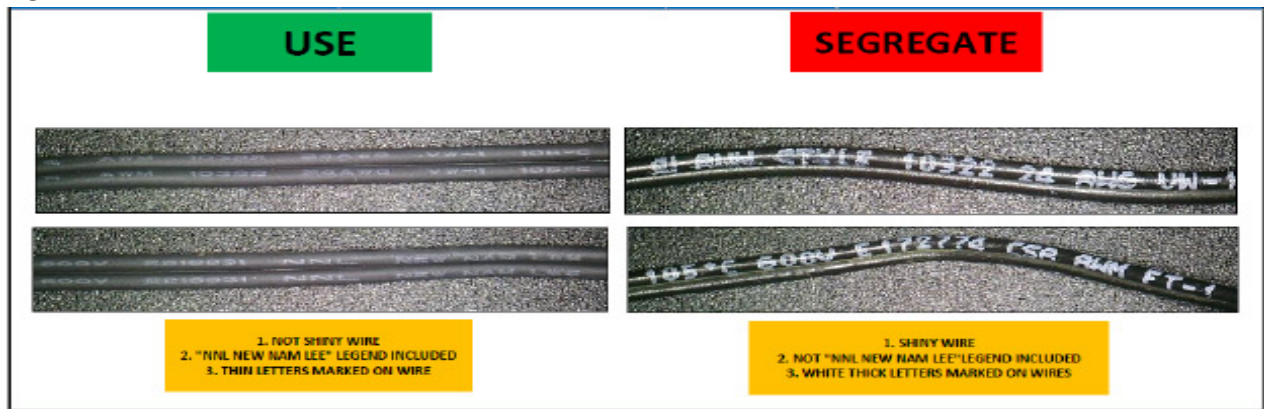
Fig 1

We have recently received reports of some defrost control sensors drifting from spec, resulting in a fault code and/or incomplete defrost cycles on Ruud heat pumps. The failures pertain to machines with part number 47-102710-17 or service replacement part 47-102710-02. Analysis of returned components have identified moisture in the sensor housing is causing the malfunction.

Beginning July 1, 2019, a new UL requirement caused a vendor change for the defrost control sensor leads. The new leads have a slightly smaller diameter. As a result, the wire *may not* be making a proper seal at the penetration point of the sensor housing. The original sensor with no known issues had wire leads with a dull matte finish, while the wire leads of the suspect sensors have more of a sheen finish. See Fig 1.

Ruud heat pumps within the production range demonstrating improper/incomplete defrost cycles must have the sensor replaced using the **new parts kit PD476604** (date code 21-01-25 or higher). The kit includes an ambient sensor and a coil defrost sensor. Be advised, Allied HVAC Distributors has pulled the previous generation sensor from our shelves. This new parts kit is on order at the time of this letter, but stock is limited. We are taking all available actions to expedite shipment. Please note there is a substitute generic sensor available from Honeywell that is stocked around the company. Call your local branch manager for details.
