**#DS-EN021622**

**Frozen or Blank Screen on EcoNet Control Center**

**Units Involved:** UETST601SYS

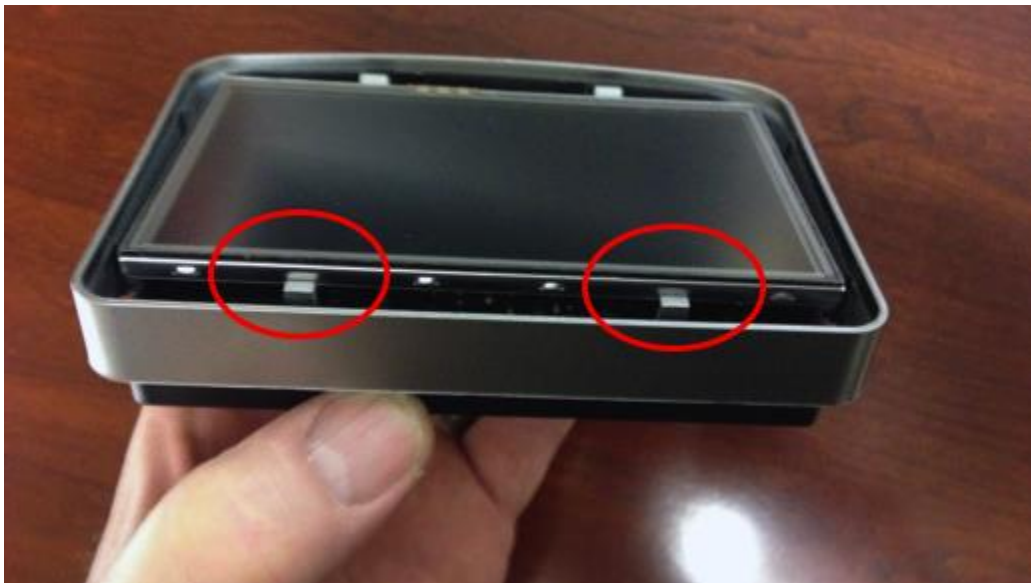
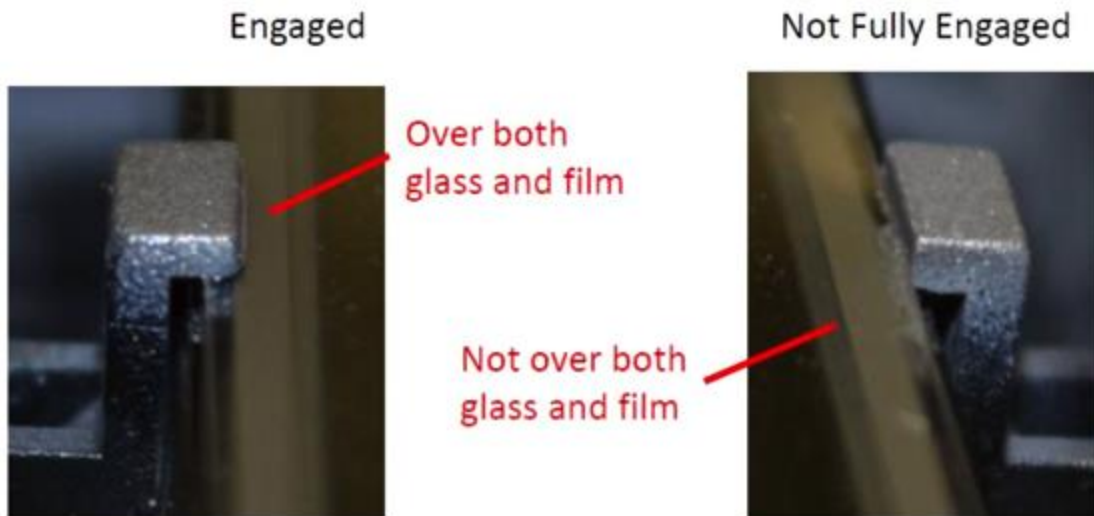
We have received reports of EcoNet Control Centers that do not respond to touch upon installation. In almost all cases, this is caused by the trim bezel contacting the screen. This is a result of movement of the screen during assembly or transport.

Remove the control from the sub-base and then by removing the trim bezel from the front of the control and make sure the screen is centered and correctly seated under all four of the screen retainer tips. Ensure the clips are fully engaged on the glass as seen in the image above.

Once the control's display touch screen is correctly seated and centered, snap the trim bezel back on and install the EcoNet Control Center back onto the wall plate.
