Issue Date: November 4, 2015

GAS FURNACES

DS-GF111510

PRODUCT ALERT

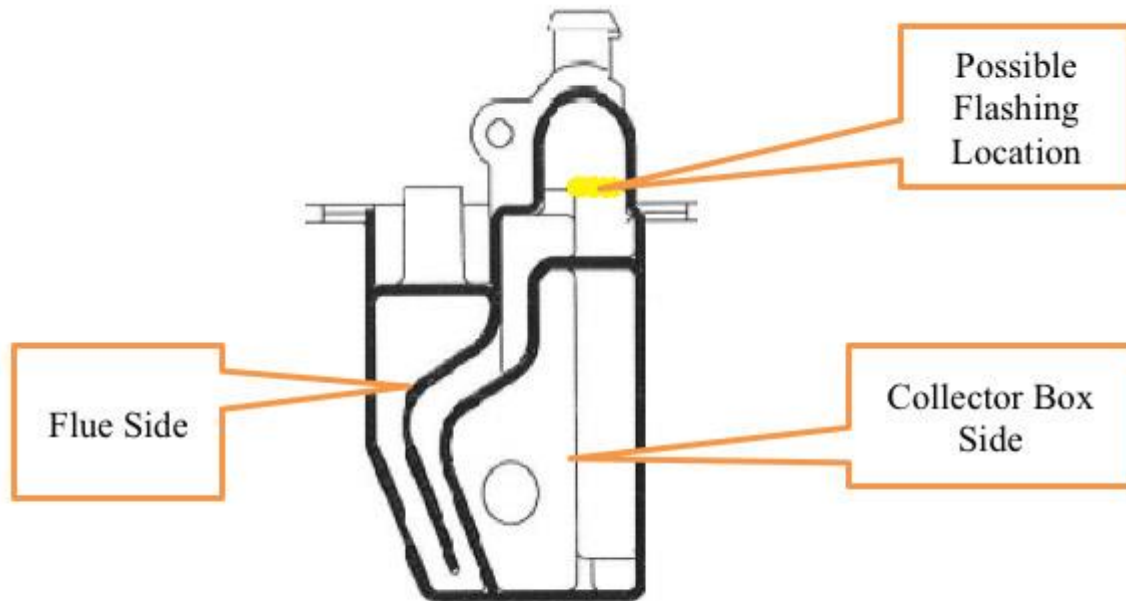
A few furnaces manufactured within date code W0515 through W3415 may experience a failed drain trap. Fault code 59 water sensed/blocked drain and Fault code 10 soft lockout will be alternating on the seven segment LED's with a call for heat if the drain trap is defective. The drain trap defect is due to a maintenance issue in a drain trap mold resulting in flashing, extra plastic material overflowing in the molding process, sealing the collector box side of the trap. The drain trap molds have been corrected and additional maintenance steps have been put in place to prevent this issue from occurring in the future. Additionally, 100% inspection of drain traps was implemented September 30th by both Ruud and our supplier.

Drain traps in furnaces within date code W0515 through W3415 should be inspected during the furnace installation. If flashing is present the drain trap is defective and must be replaced. Drain traps have been inspected and will be provided within normal warranty process through Rheem/Ruud replacement parts. Removing the excess flashing from the drain trap is not recommended. For reliable furnace operation the drain trap should be replaced. Please contact your assigned district technical representative with any questions.
